Case study: Estela golf course beach (Portugal)

Technique: Dune rehabilitation

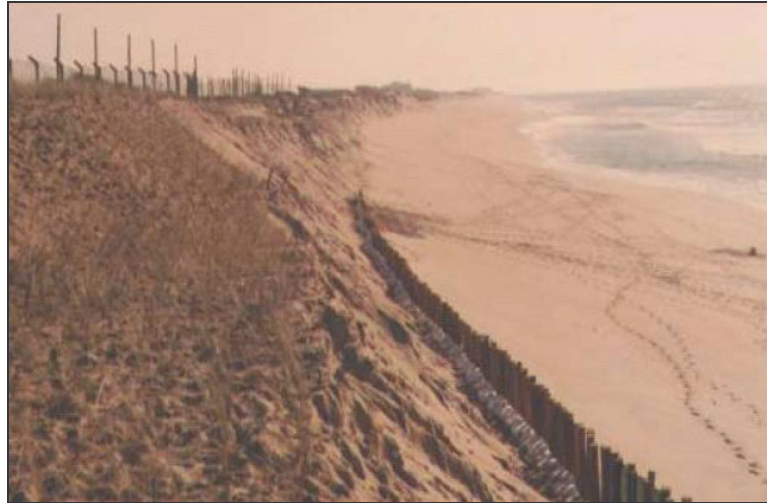
Figure 2: Dune consolidation with wood piles and small sand bags, April 1999.
(Source: Estela. EUROSION case study, at <http://www.euroasion.org>)

The first documented intervention, made during the period of 1st to 12th April 1999, consisted on located reinforcement of the dune toe through mechanical ripping of sand from the frontal beach and consolidation of this sand deposit with wood piles and small sand bags of 5 kg weight (see Figure 2). This intervention was simultaneously made on the critical zone 1 (CZ1), near the 5th hole and on critical zone 2 (CZ2), near the 13th hole.

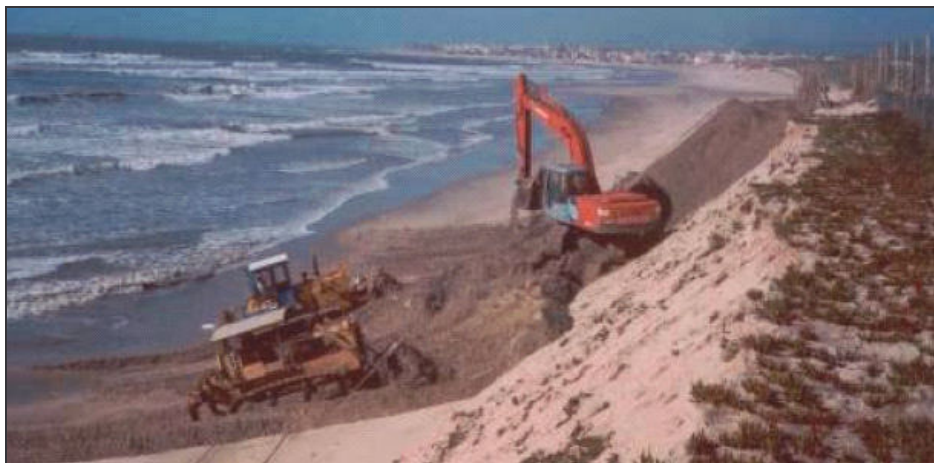
Figure 3: Sand ripping works near the 5th hole, October 2000.
(Source: Estela. EUROSION case study, at <http://www.euroasion.org>)

The 5th intervention near hole number 5 was made in October 2000 (see Figure 3), after the spring tides occurred in 28th and 29th September, that had as a consequence the partial destruction of the dunar system in that area which motivated once more the need to prosecute with dune renourishment works.

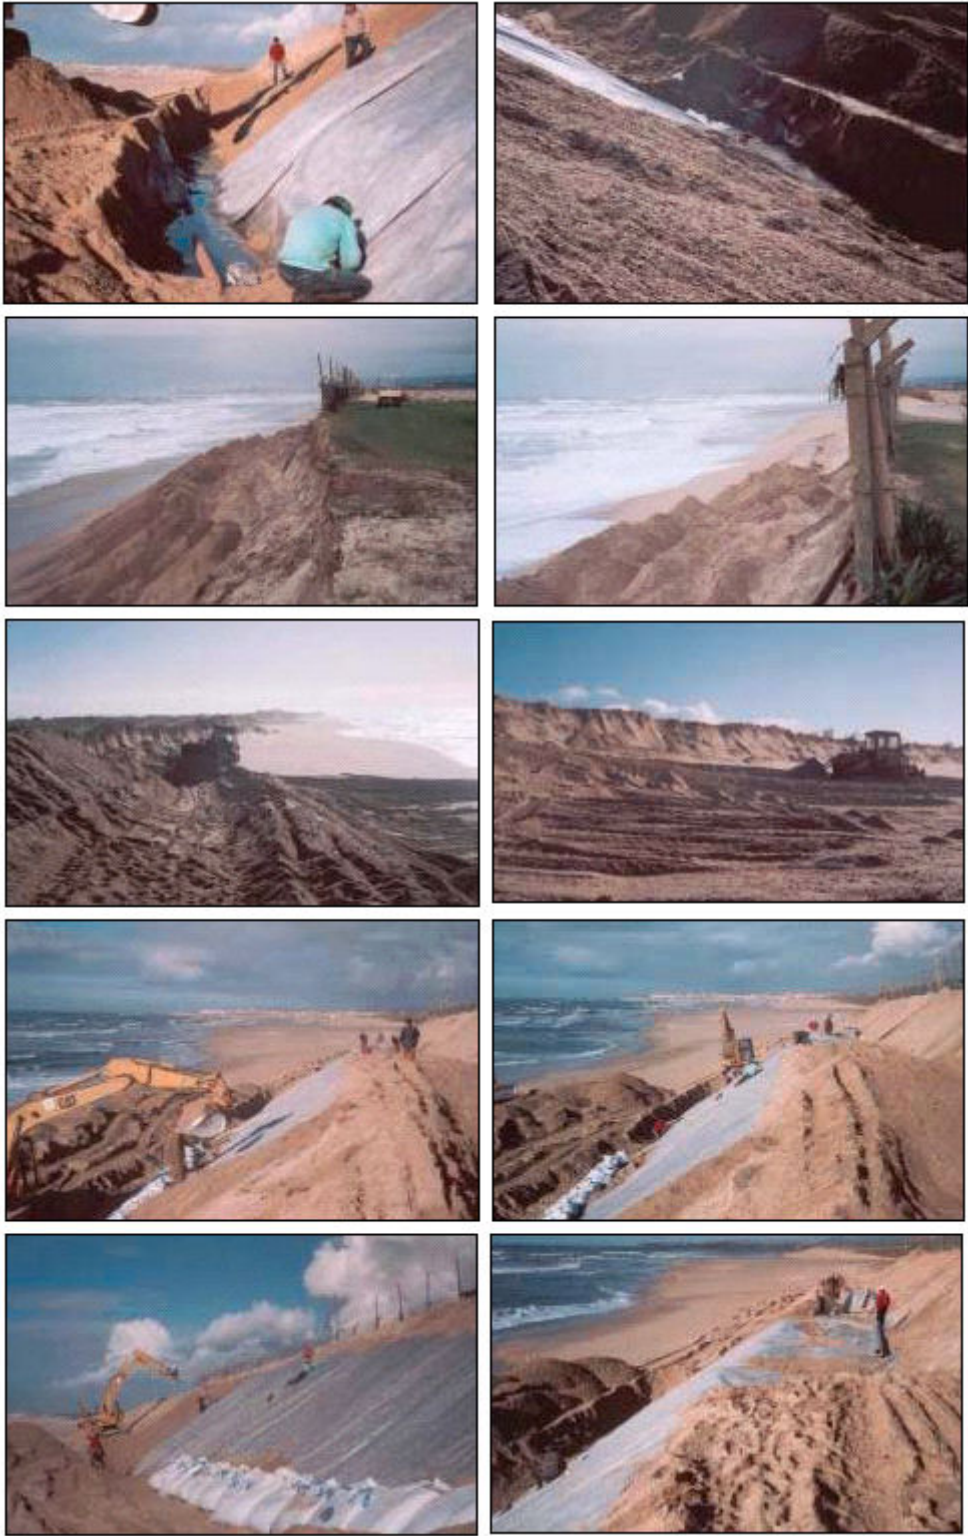
Figure 4: Aspects of the execution of the technical solution using geotextile sand containers, December 2000.
(Source: Estela. EUROSION case study, at <http://www.eurosion.org>)

December 2000 marks the beginning of the use of a new technique of coastal defence in association with the sand ripping. The severe spring tides and storms that affected this area since October, causing a series of dune destruction events, were responsible for the decision to make use of a more solid reinforcement technique that consisted on a slope protection of the dune with a geotextile filter cloth underlay and sand containers of 1m³ (see Figure 4). The intervention was carried out in 3 stretches with 350, 70 and 50m and consisted on the placing of a geotextile filter cloth and sand containers along a 45° slope. During October and December 2001 and May 2002 new sand containers were placed on the dune slope, but this time the geotextile filter cloth underlay was not placed.
